Contract #: 04-0120F4Cty: SF/ALA Rte: 80 PM: 13.2/13.9File #: 99.28**WELDING INSPECTION REPORT**

**Report No:** WIR-027667  
**Date Inspected:** 18-May-2012

**Project Name:** SAS Superstructure  
**Prime Contractor:** American Bridge/Fluor Enterprises, a JV  
**Contractor:** Lubrite Industries

<b>CWI Name:</b>	Brad McWright	<b>CWI Present:</b>	Yes	No
<b>Inspected CWI report:</b>	Yes No N/A	<b>Rod Oven in Use:</b>	Yes No N/A	
<b>Electrode to specification:</b>	Yes No N/A	<b>Weld Procedures Followed:</b>	Yes No N/A	
<b>Qualified Welders:</b>	Yes No N/A	<b>Verified Joint Fit-up:</b>	Yes No N/A	
<b>Approved Drawings:</b>	Yes No N/A	<b>Approved WPS:</b>	Yes No N/A	
		<b>Delayed / Cancelled:</b>	Yes No N/A	
<b>Bridge No:</b>	34-0006	<b>Component:</b>	Spherical Bearing Hinge HK

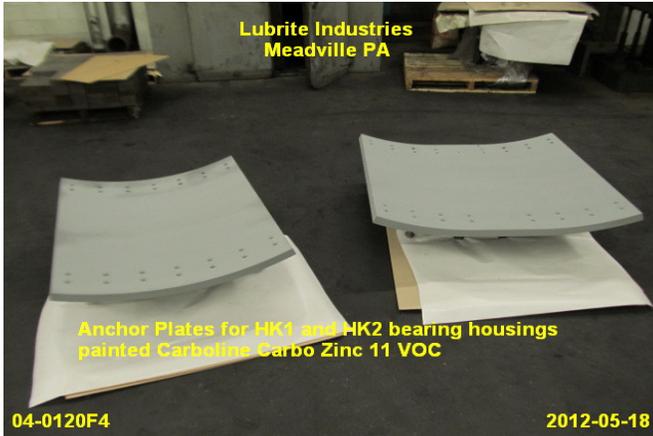
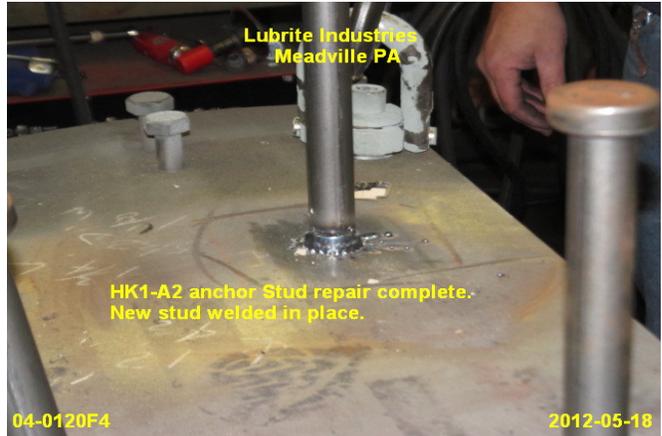
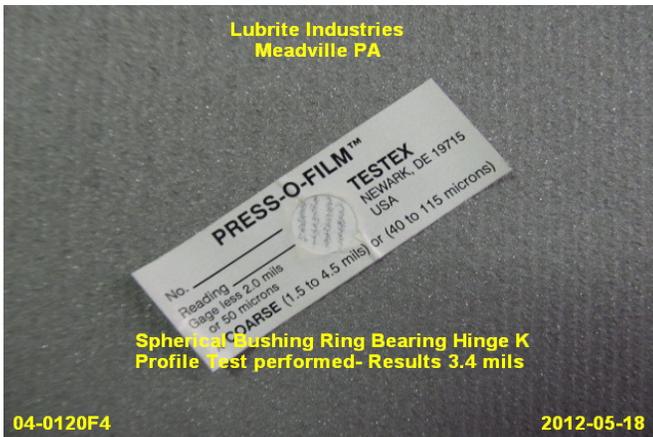
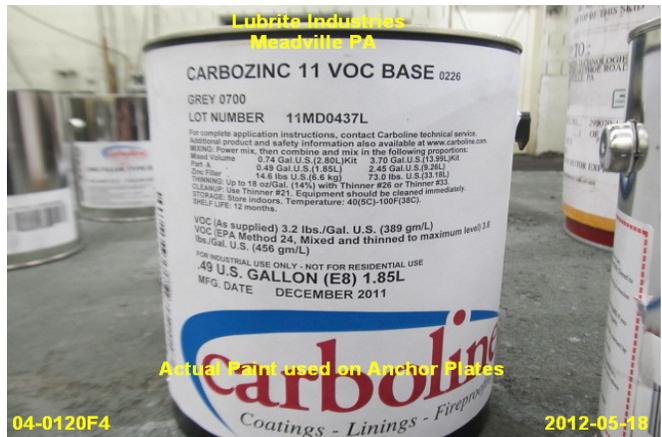
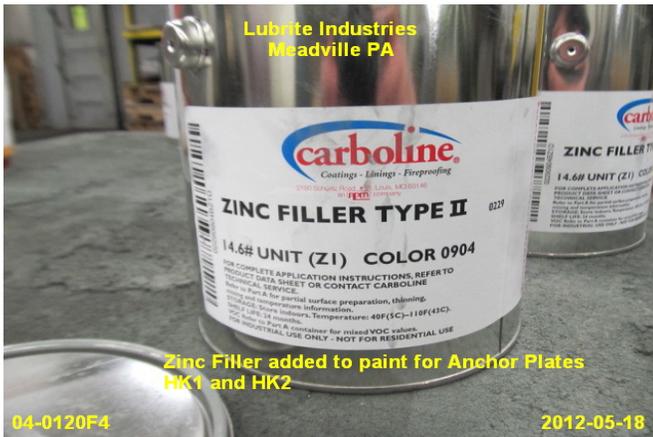
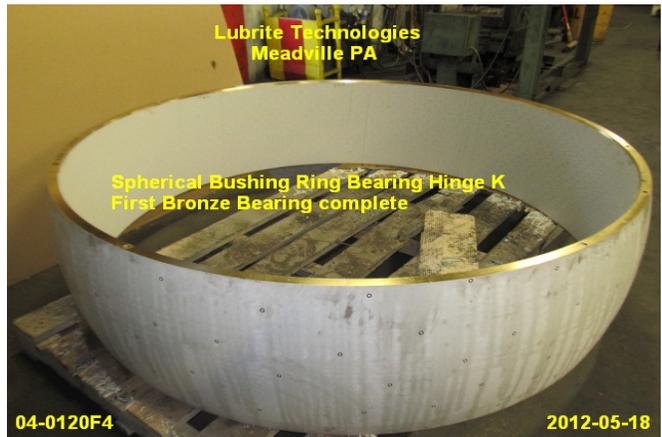
This Quality Assurance Inspector (QAI) arrived at Lubrite Industries (LI), Meadville PA, as requested to monitor the welding of the repair Anchor Stud to the Anchor Plate HK1-A2 and for the painting of the anchor plates for Bearing Assemblies HK1 and HK2.

Upon arrival this QAI met with Third Party QC Reno Davis KTA (TPQC), and Brad McWright (LIQC). The plate material is ASTM A709 Grade 50 Heat 0502434. Anchor studs are 1" x 8 1/4" ASTM A108/A29 Grade 1015 Heat 5093721. The HK1-A2 anchor plate was set up for welding of the final anchor stud to the damaged area of the plate. A test plate was used first to ensure proper welding of two test studs. The test studs were then bent to 60 degrees to verify adhesion. Stud was then welded to production plate in accordance with approved stud welding procedure. Stud was then bent to 15 degrees per TPQC request. TPQC inspected the welding and accepted the anchor plate.

Also noted on this visit was the completed Bronze bearing to be used in the first completed unit.
